# Portola Valley Home Energy Study Report

During March and April of 2008, energy evaluations were performed on five homes in Portola Valley. The findings are reported collectively below.

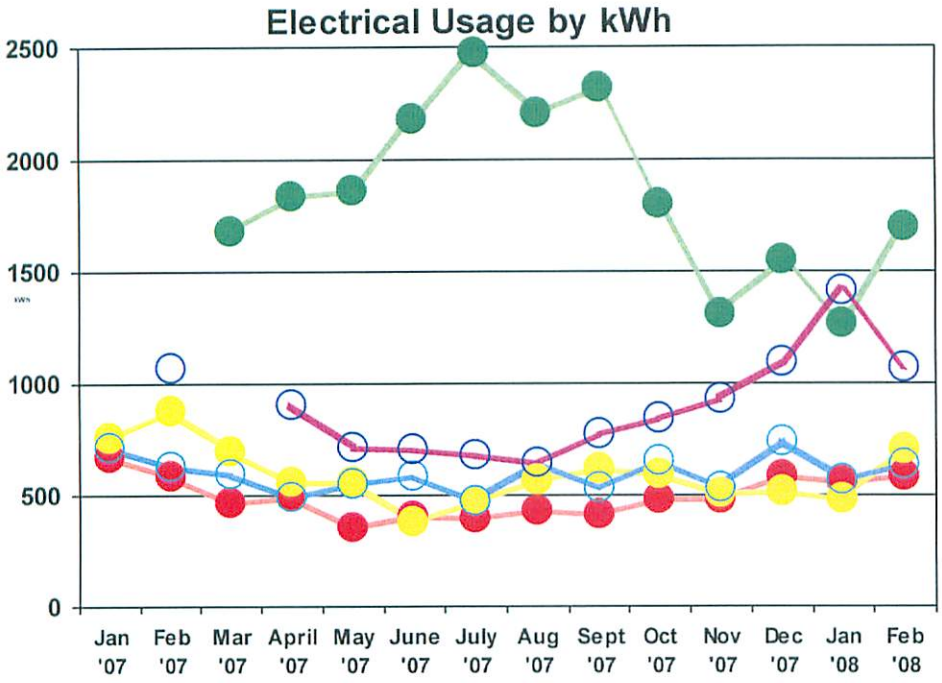
Four of the homes experience a seasonal increase in electricity use in the winter due to more extensive use of lighting. The fifth home (green line) experiences increased electricity use in the summer, possibly due to the increase in pool filtration. Note home E (purple line) installed solar photovoltaic panels in May; the numbers here are electricity purchases from PG&E not including electricity generated from the photovoltaic system.

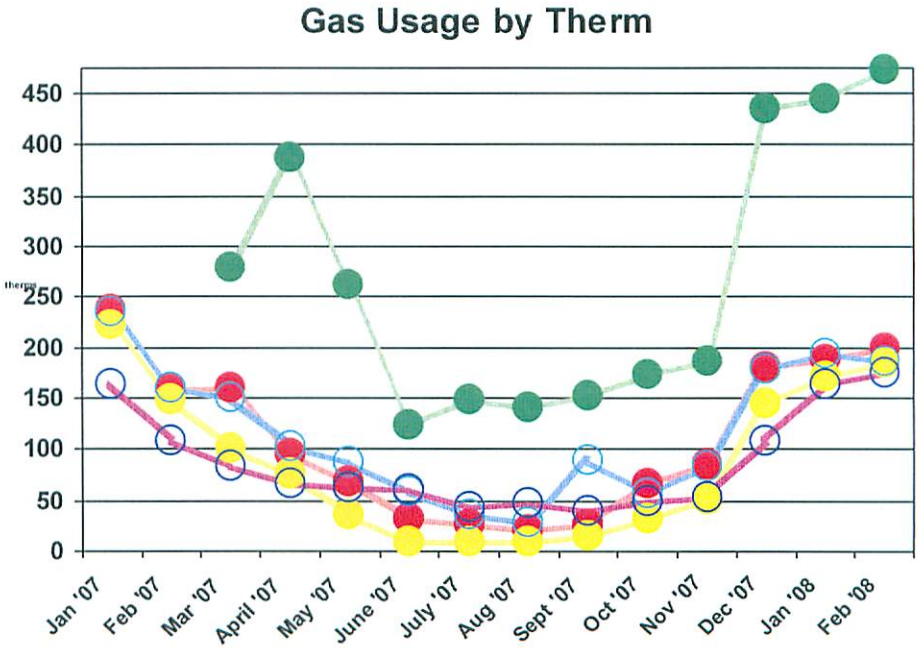
All five homes showed an expected substantial increase in natural gas use during the winter months. During the summer, three homes use only 16-26 therms of natural gas (yellow, red, and blue lines), one home (purple line) uses approximately 45 therms, while the fifth home (green line) uses approximately 152 therms. The home with the notably higher summer gas use (green line) has two hot water heaters and a gas heater for their pool and spa.

The newest of the homes (purple line) has a relatively high baseline gas use of 44 therms during the summer, but uses the least amount of gas during the winter.

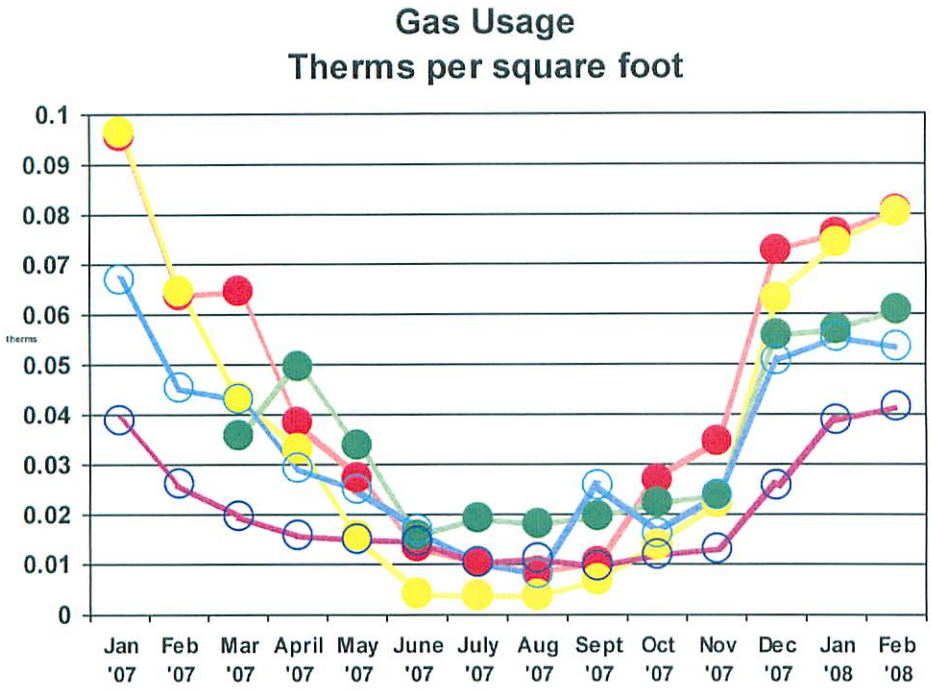
Natural gas usage can also be evaluated on a therms-per-square-foot basis. Looking at the gas use per square footage of home, the notably larger Home C (green line) is using a gas-per-square-foot rate that is comparable to the other homes. This would indicate that Home C is not performing more poorly than the other homes, just that heating a much larger home utilizes much more natural gas.

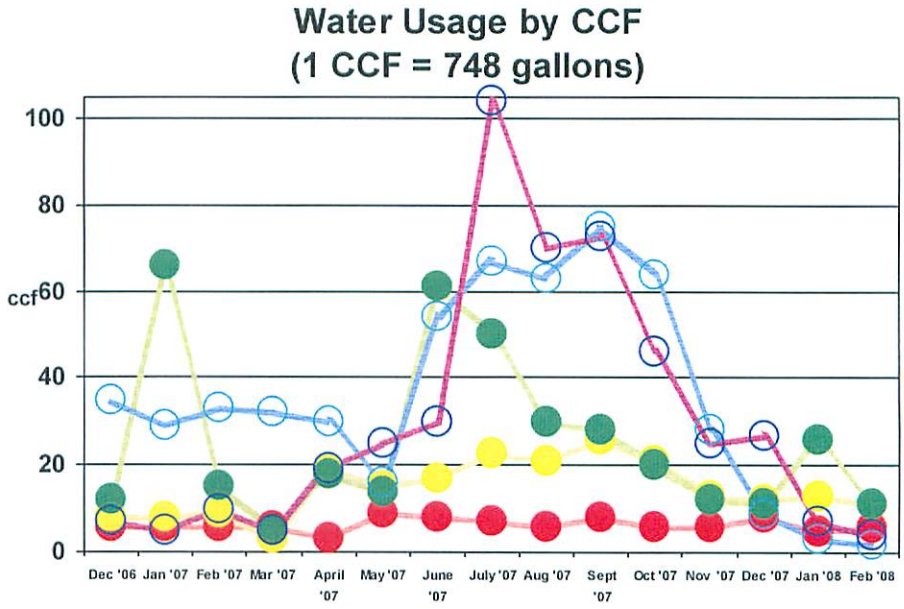
One family of four (red line) consistently uses approximately 6 ccf of water each month, equivalent to approximately 4,500 gallons; this home increases water use only approximately 2 ccf during the summer gardening season. A second home with two family members (yellow line) uses about 12 ccf of water as their baseline with increases of up to 9-14 ccf during summer months. One family of three (purple line) uses only 5 ccf as their baseline in the winter, but uses up to 104 ccf in the summer. The two homes with swimming pools (blue and green lines), also use about 3 and 12 ccf of water as their baselines, but experience major peaks of water use, using over five times their base water use; it is suspected that these are related to pool maintenance.

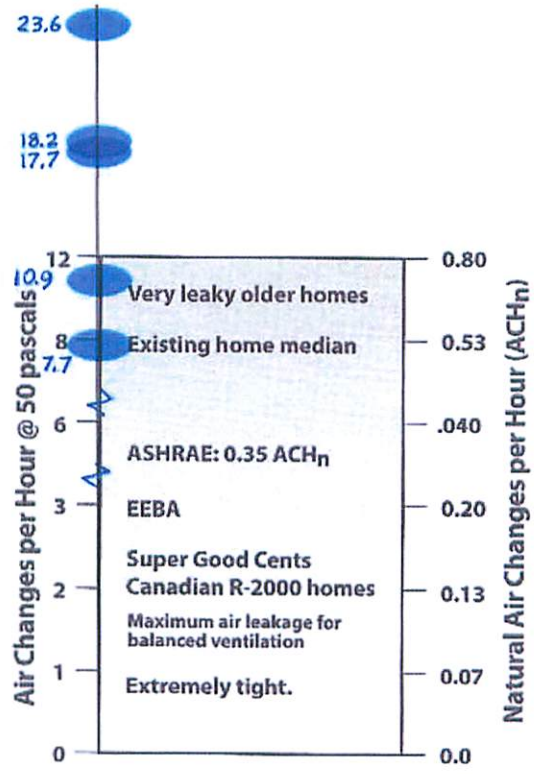
- A blower-door test was performed to measure overall air leakage of the homes and identify specific areas of leakage. Four of the five homes can be categorized as "very leaky". However, one home's air leaks are coming predominantly from its unducted air return; installation of a sealed return duct may result in that home performing substantially better on air leakage testing. A second home, if air leakage areas are corrected, could likely achieve "existing median" leakage or better.

Portola Valley homes indicated in blue. Underlying graphics © John Krigger & Chris Dorsi, *Residential Energy* (2004).

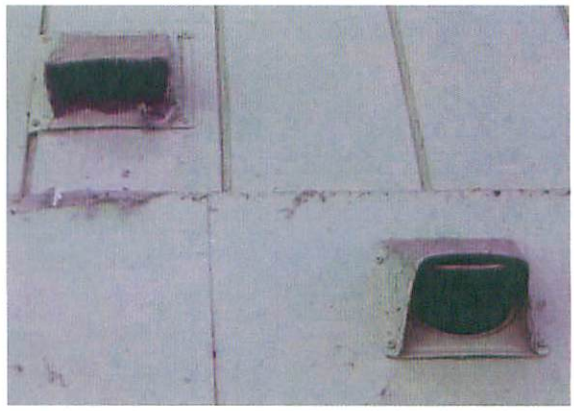
- Two homes have air leakage around the molding surrounding one or more windows. Recommendation: Window frames should be checked for separation and caulked to reduce air infiltration.
- Four homes have air leakage through bathroom fans. Recommendation: The outside end of the fan duct should be checked to confirm that a gravity flapper closes the fan duct when not in use. The recessed portion of the fan should be sealed from the attic side and insulated.

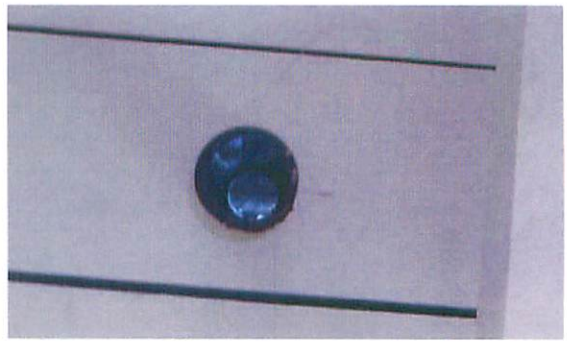
- One home has dryer and bathroom fan exterior vents that appear to be blocked open. Recommendation: Assure fan and exhaust vents have functioning gravity flappers to close the vents when exhaust air is not being released. Dryer vents should be checked for excess lint buildup annually.
- One home has an unsealed, interior-style door between the home and its attached garage. Recommendation: The interior-style door should be replaced with an exterior-style door with a good seal, to reduce air infiltration from the garage and comply with fire safety codes.
- One home has tubes leading out of the ceiling of upstairs bedrooms and through the roof, the purpose of which was not clear.

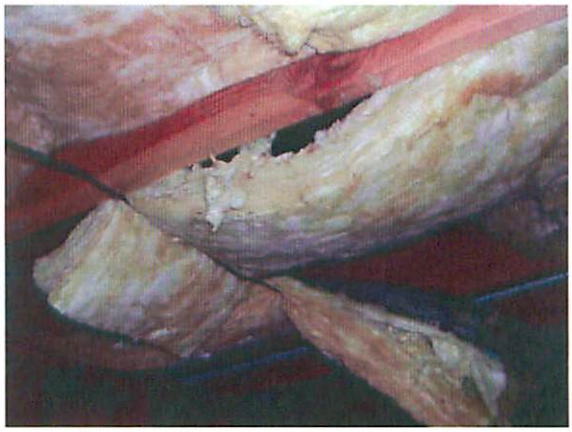
- Four of the homes have known or believed presence of wall insulation. It is not known whether the remaining home has wall insulation. Recommendation: Wall insulation can be checked or confirmed by drilling one or more holes in the wall. Where wall insulation is present but insufficient, depending on the type of insulation, it may be possible to retrofit additional loose-fill insulation into the wall cavity. Insulation can be retrofitted either from the inside or the outside of the home. One or more holes would need to be drilled in each stud bay to insert the insulation tubes, so it should be anticipated that the home will need to be repainted afterwards.

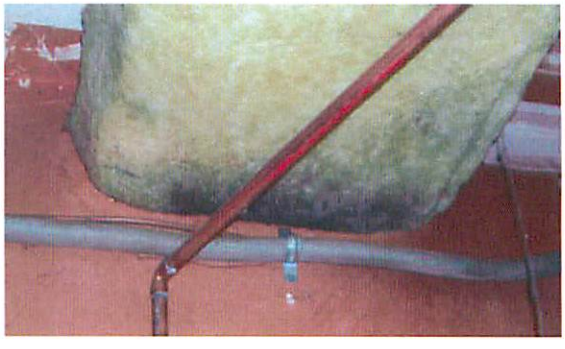
- Analyzed homes with heat ducts have moderately to extremely leaky duct systems. Bands of discoloration on duct insulation at one home show locations of duct leaks. Recommendation: An HVAC contractor should use mastic to seal all seams and connections in the air ducts and plenums. An alternative to using mastic to seal from the outside is the Aeroseal duct sealant system, in which aerosolized adhesive is blown into the duct system to seal leakage from the inside. The HVAC contractor should also seal all duct "boot" connections to the walls and floors where they enter the home.

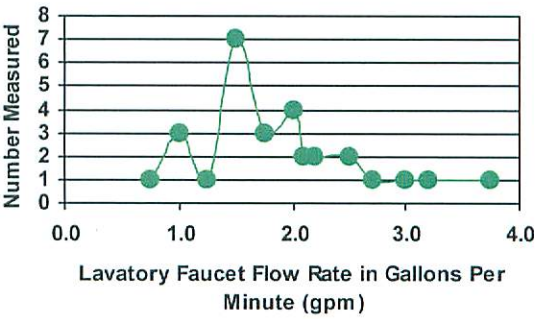
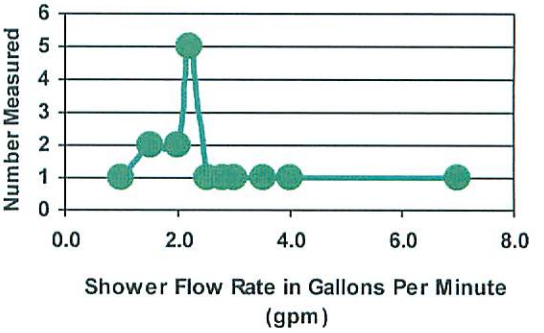
- Of the 16 showerheads analyzed, 5 provide flow greater than 2.5 gpm. Recommendation: All showerheads now manufactured in the U.S. must restrict flow to 2.5 gallons per minute (gpm) or less. Replace any using more than 2.5 gpm.
