<b>Type of Services</b>	<b>Preliminary Geotechnical and Geologic Hazard Investigation</b>
<b>Project Name</b>	<b>The Stanford Wedge</b>
<b>Location</b>	<b>Alpine Road Portola Valley, California</b>
<b>Client</b>	<b>Stanford Real Estate</b>
<b>Client Address</b>	<b>3160 Porter Drive, Suite 200 Palo Alto, California</b>
<b>Project Number</b>	<b>105-117-1</b>
<b>Date</b>	<b>September 18, 2017</b>

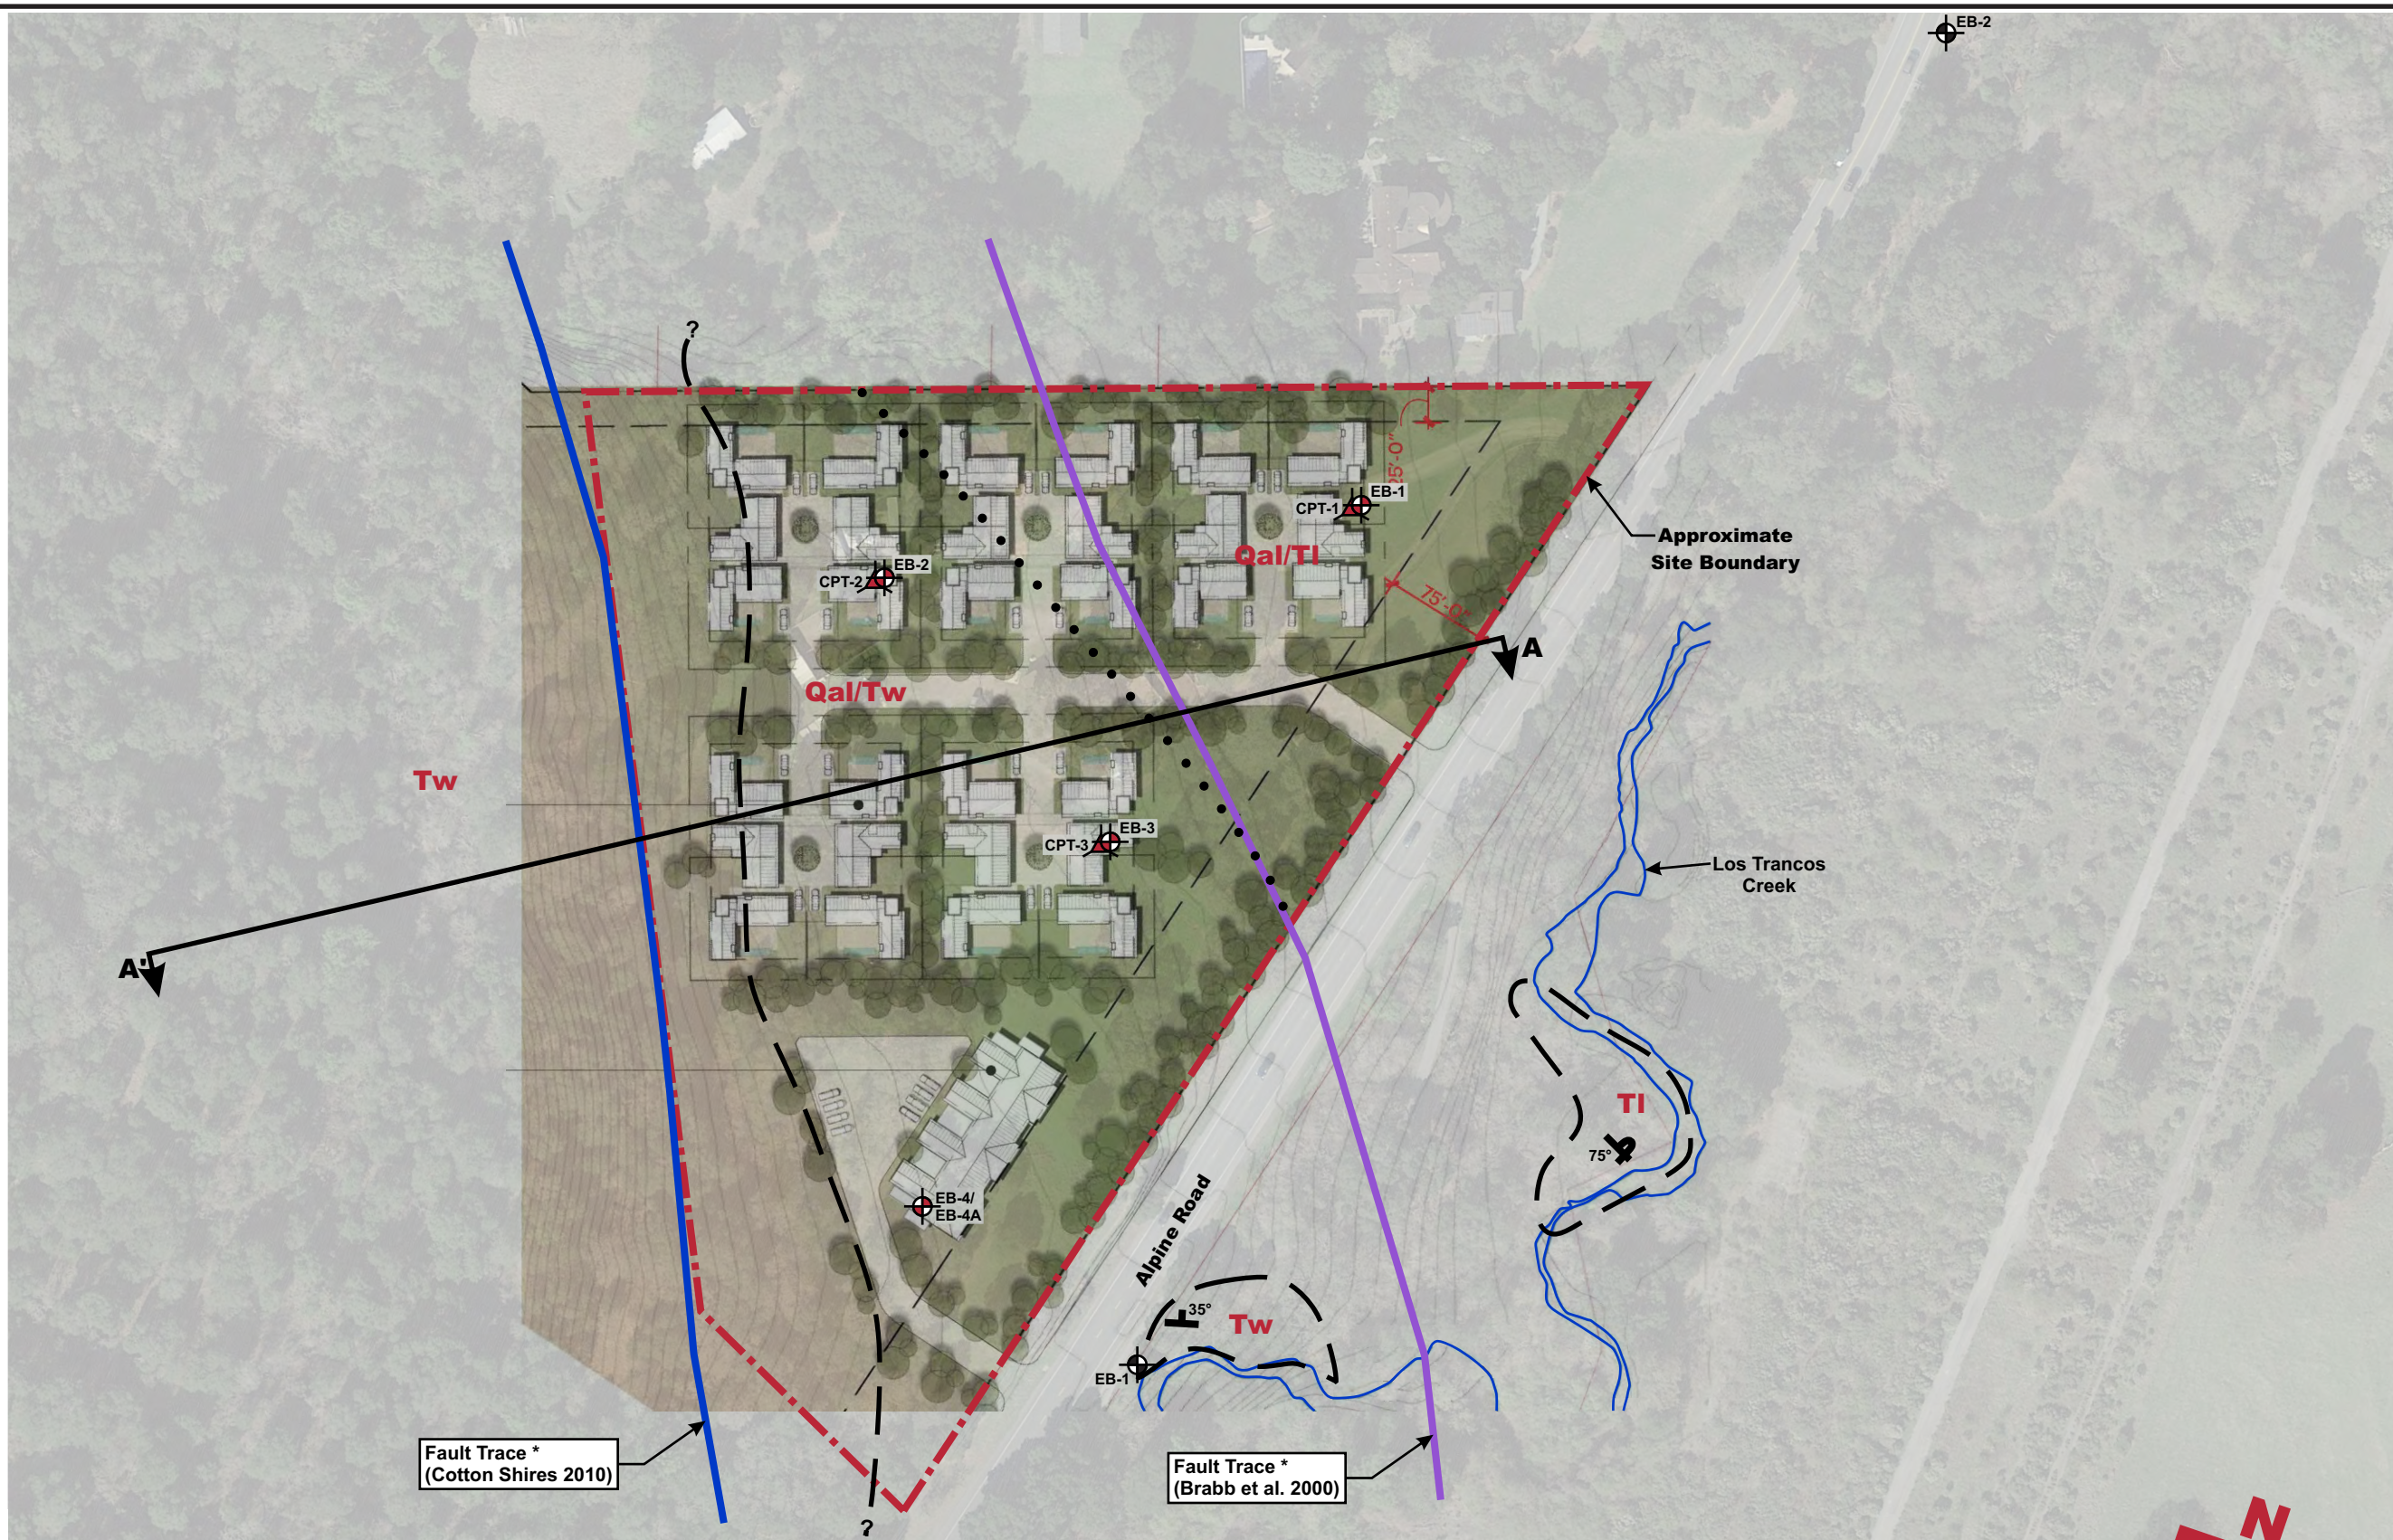
Site Plan and Geologic Map  
The Stanford Wedge  
Portola Valley, CA

\* Mapped fault traces dropped from current town geologic map due to lack of evidence. Brabb et. al mapping of fault is considered to be a depositional contact.

Base by Google Earth, dated 11/2/2017  
Overlay by HKS Hospitality Group, Site Plan: Option A, dated 8/10/2016

The borings and CPTs were backfilled with cement grout in accordance with local requirements; exploration permits were obtained as required by local jurisdictions. The approximate locations of our exploratory borings and CPTs are shown on the Site Plan and Geologic Map, Figure 2. Details regarding our field program are included in Appendix A. Figure 2 also shows our previous field investigation from the C-1 Trails project; the details of the previous investigation are included in Appendix C.

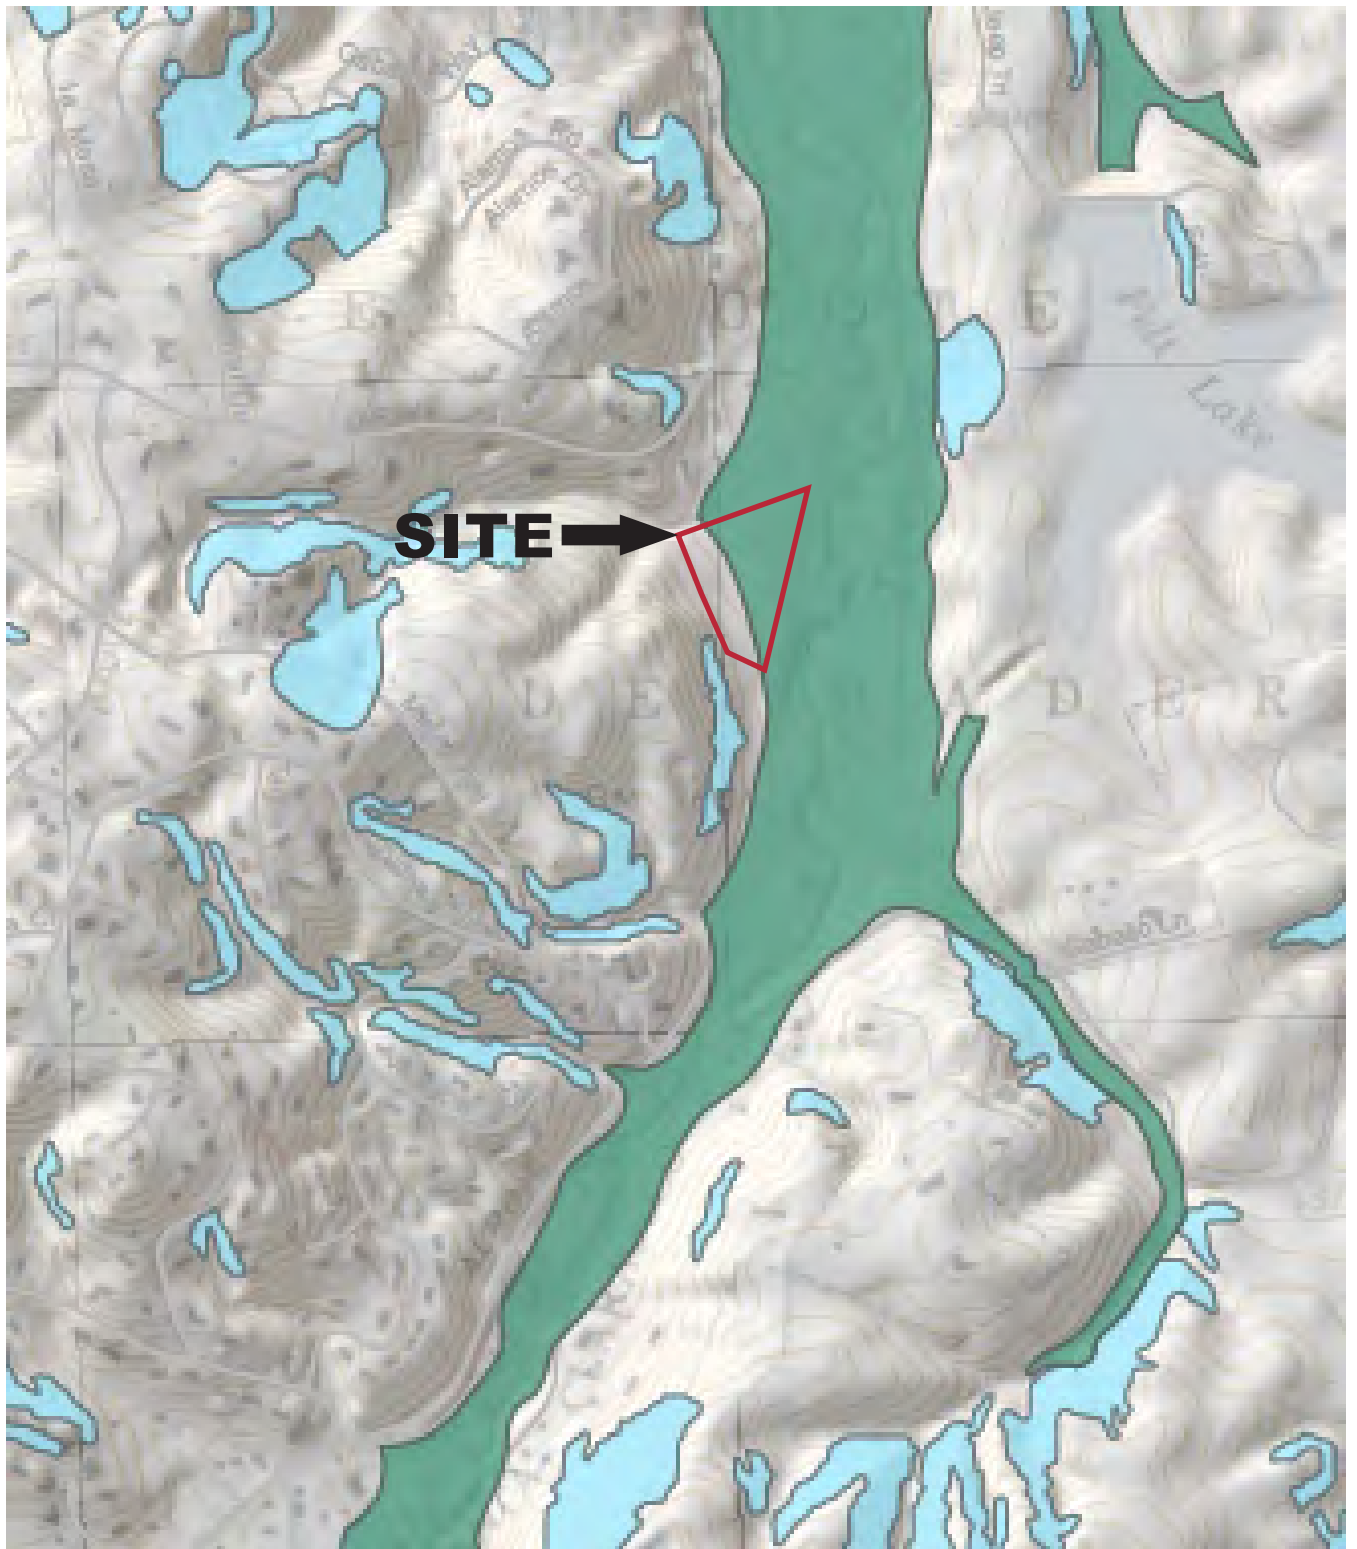
CGS Seismic Hazard Map

Areas where historic occurrence of liquefaction, or local geological, geotechnical and groundwater conditions indicate a potential for permanent ground displacements such that mitigation as defined in Public Resources Code Section 2693(c) would be required.
- Earthquake-Induced Landslides**

The eastern portion of the site is within a State-designated Liquefaction Hazard Zone (CGS, Palo Alto Quadrangle, 2006), as depicted on Figure 6. Additionally, as shown on the “Ground Movement Potential Map,” Figure 5, most of the site is depicted as being in area “Sun” described as “...liquefaction possible at valley floor sites during strong earthquakes.” Our field and laboratory programs addressed this issue by testing and sampling potentially liquefiable layers, performing visual classification on sampled materials, evaluating CPT data, and performing various tests to further classify soil properties.

As shown on the “CGS Seismic Hazard Map” Figure 6, an earthquake-induced landslide zone is mapped by the California Geologic Survey adjacent to the southwest end of the site within the slope along the southwest perimeter of the site (CGS, 2006). Also, the ground movement potential map (by CSA, 2017) indicates slopes in this area of the site are designated with a “sbr” mapping symbol. The “sbr” designation is characterized as “Level ground to moderately steep slopes underlain by bedrock within approximately three feet of the ground surface or less; relatively thin soil mantle may be subject to shallow landsliding, settlement, and soil creep.” Our review of maps, reconnaissance and observations of outcrops in the area suggest this slope is underlain by the Whiskey Hill Formation which is generally semi-cemented and in a very dense condition.

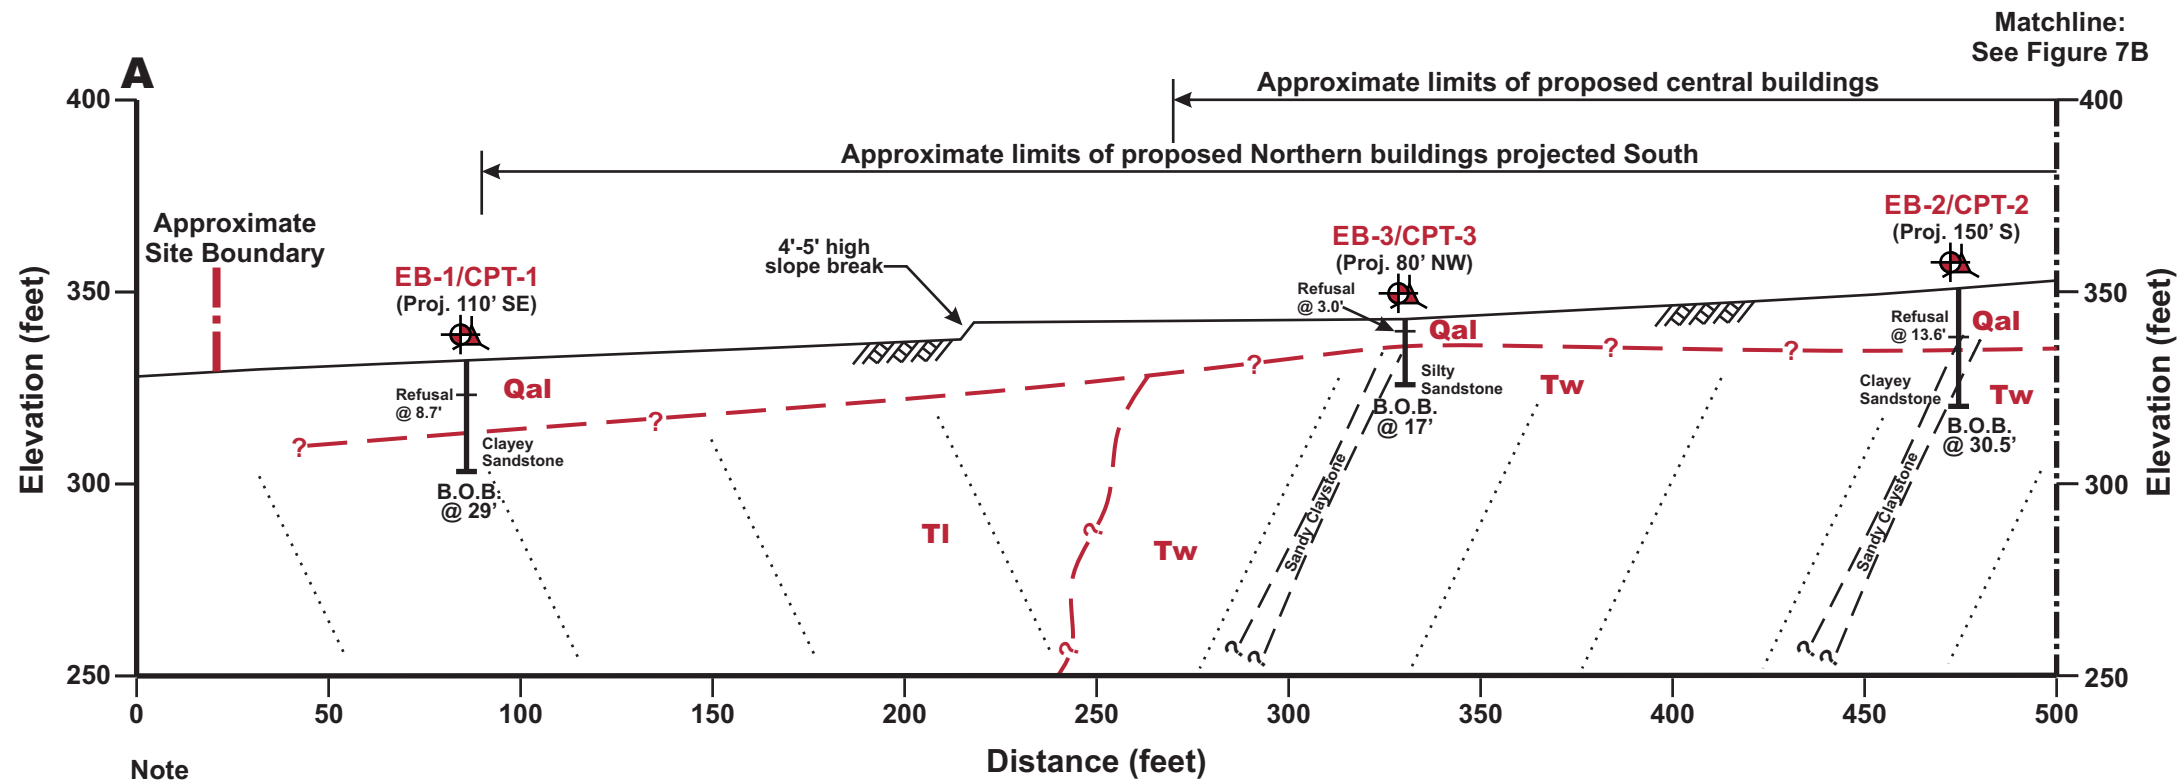
Figure Number  
Figure 7A

**Note**  
Bedrock dip angle by  
Craig Harwood, C.E.G.

**Section A-A'**  
(View Looking Southeast)  
1"=50' H:V

- 1) Topographic information: Exhibits.pdf, Glenoaks and Turchet Lease.
- 2) Surficial fills associated with existing pavements, landscaping or utilities are not shown.
- 3) The subsurface profile is conceptual and is based on limited subsurface data obtained from widely spaced borings. Actual subsurface conditions may vary significantly between borings.
- 4) See Figure 2 for location of cross section.

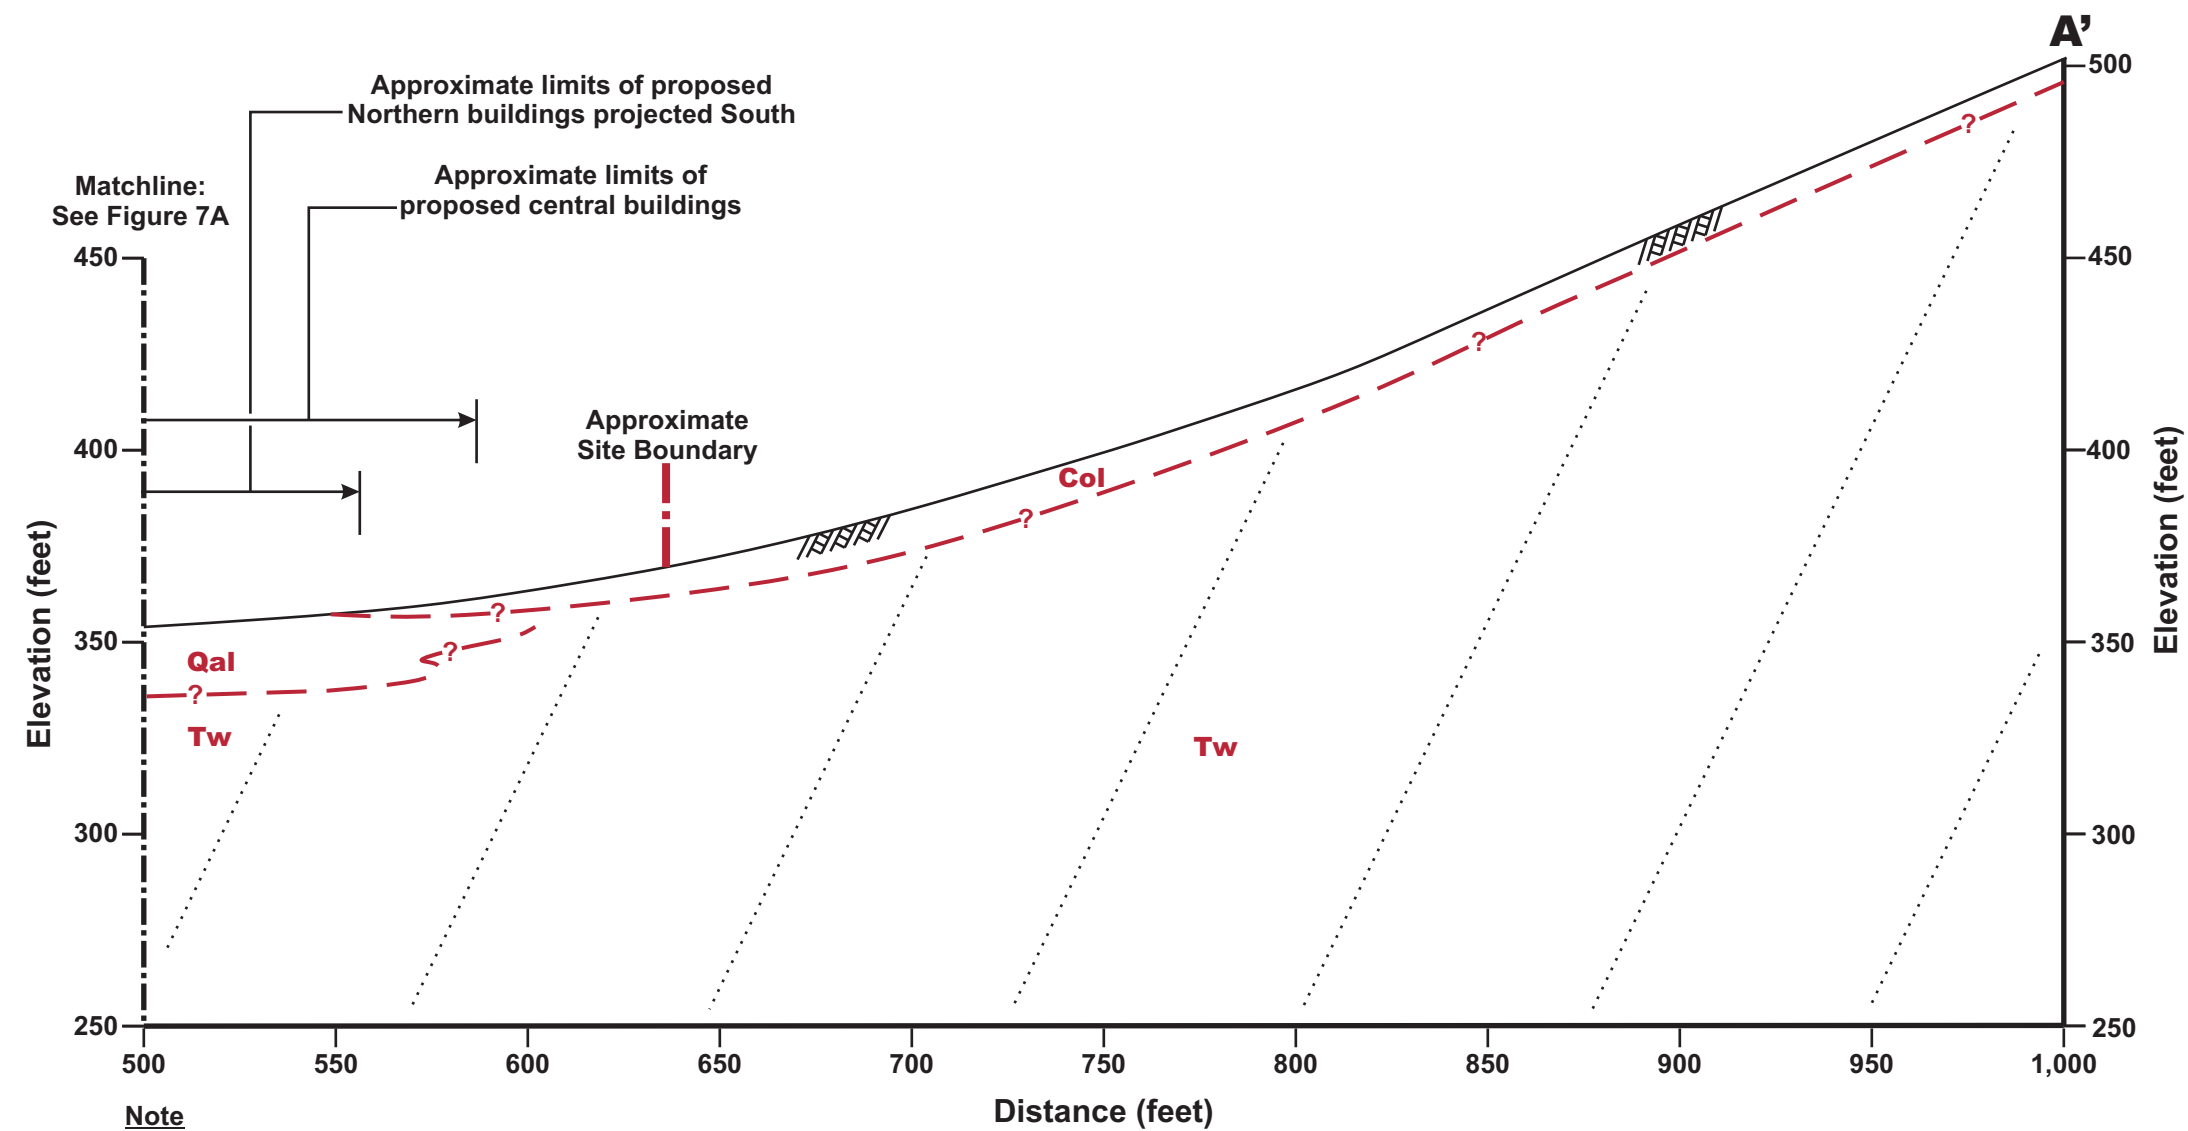
Figure Number  
Figure 7B

**Note**  
Bedrock dip angle by  
Craig Harwood, C.E.G.

**Section A-A'**  
(View Looking Southeast)  
1"=50' H:V

- 1) Topographic information: Exhibits.pdf, Glenoaks and Turchet Lease.
- 2) Surficial fills associated with existing pavements, landscaping or utilities are not shown.
- 3) The subsurface profile is conceptual and is based on limited subsurface data obtained from widely spaced borings. Actual subsurface conditions may vary significantly between borings.
- 4) See Figure 2 for location of cross section.

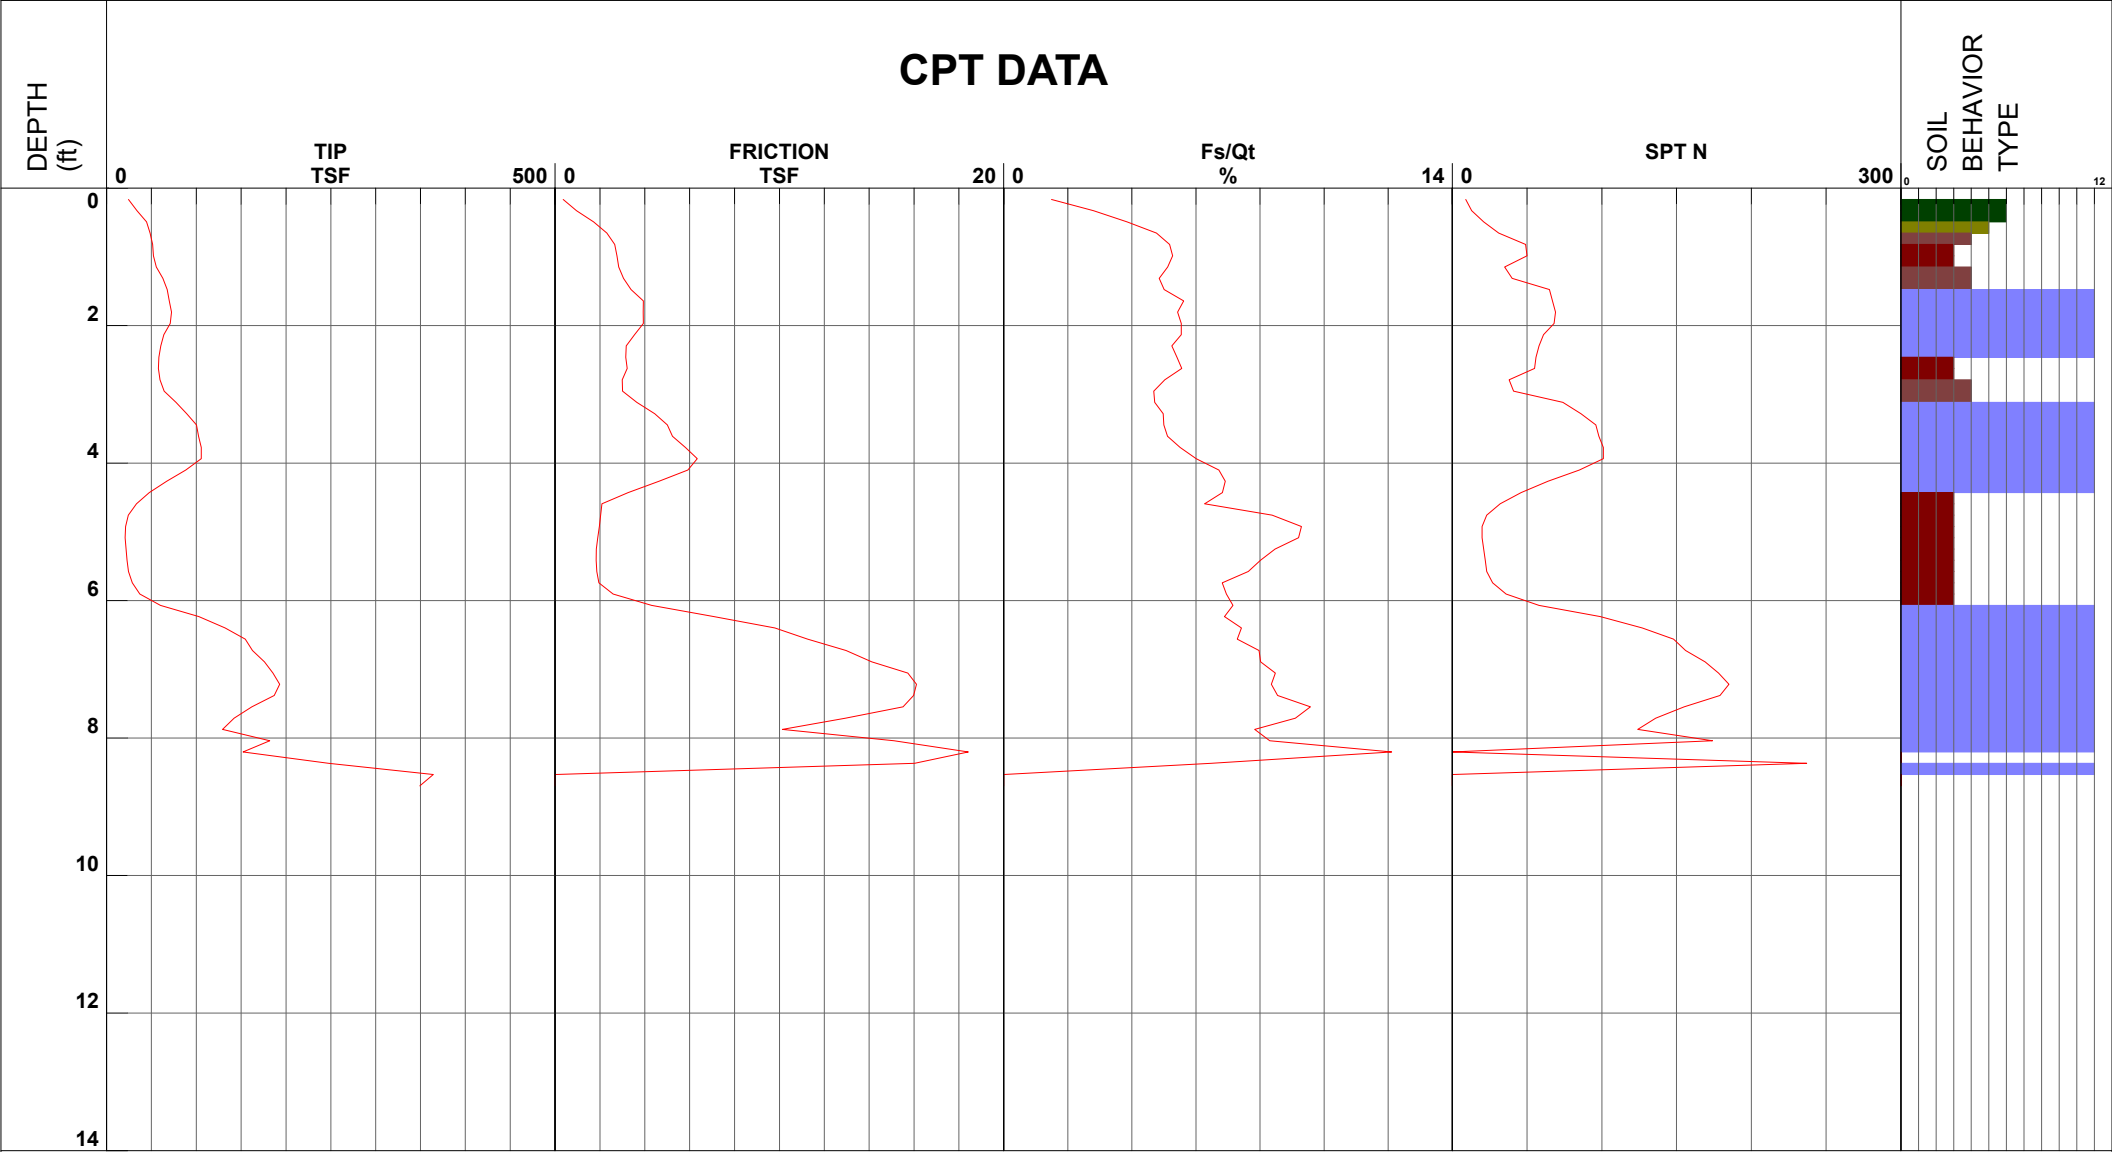
## CPT DATA

SOIL BEHAVIOR TYPE

- 1 - sensitive fine grained
- 4 - silty clay to clay
- 7 - silty sand to sandy silt
- 10 - gravelly sand to sand
- 2 - organic material
- 5 - clayey silt to silty clay
- 8 - sand to silty sand
- 11 - very stiff fine grained (\*)
- 3 - clay
- 6 - sandy silt to clayey silt
- 9 - sand
- 12 - sand to clayey sand (\*)

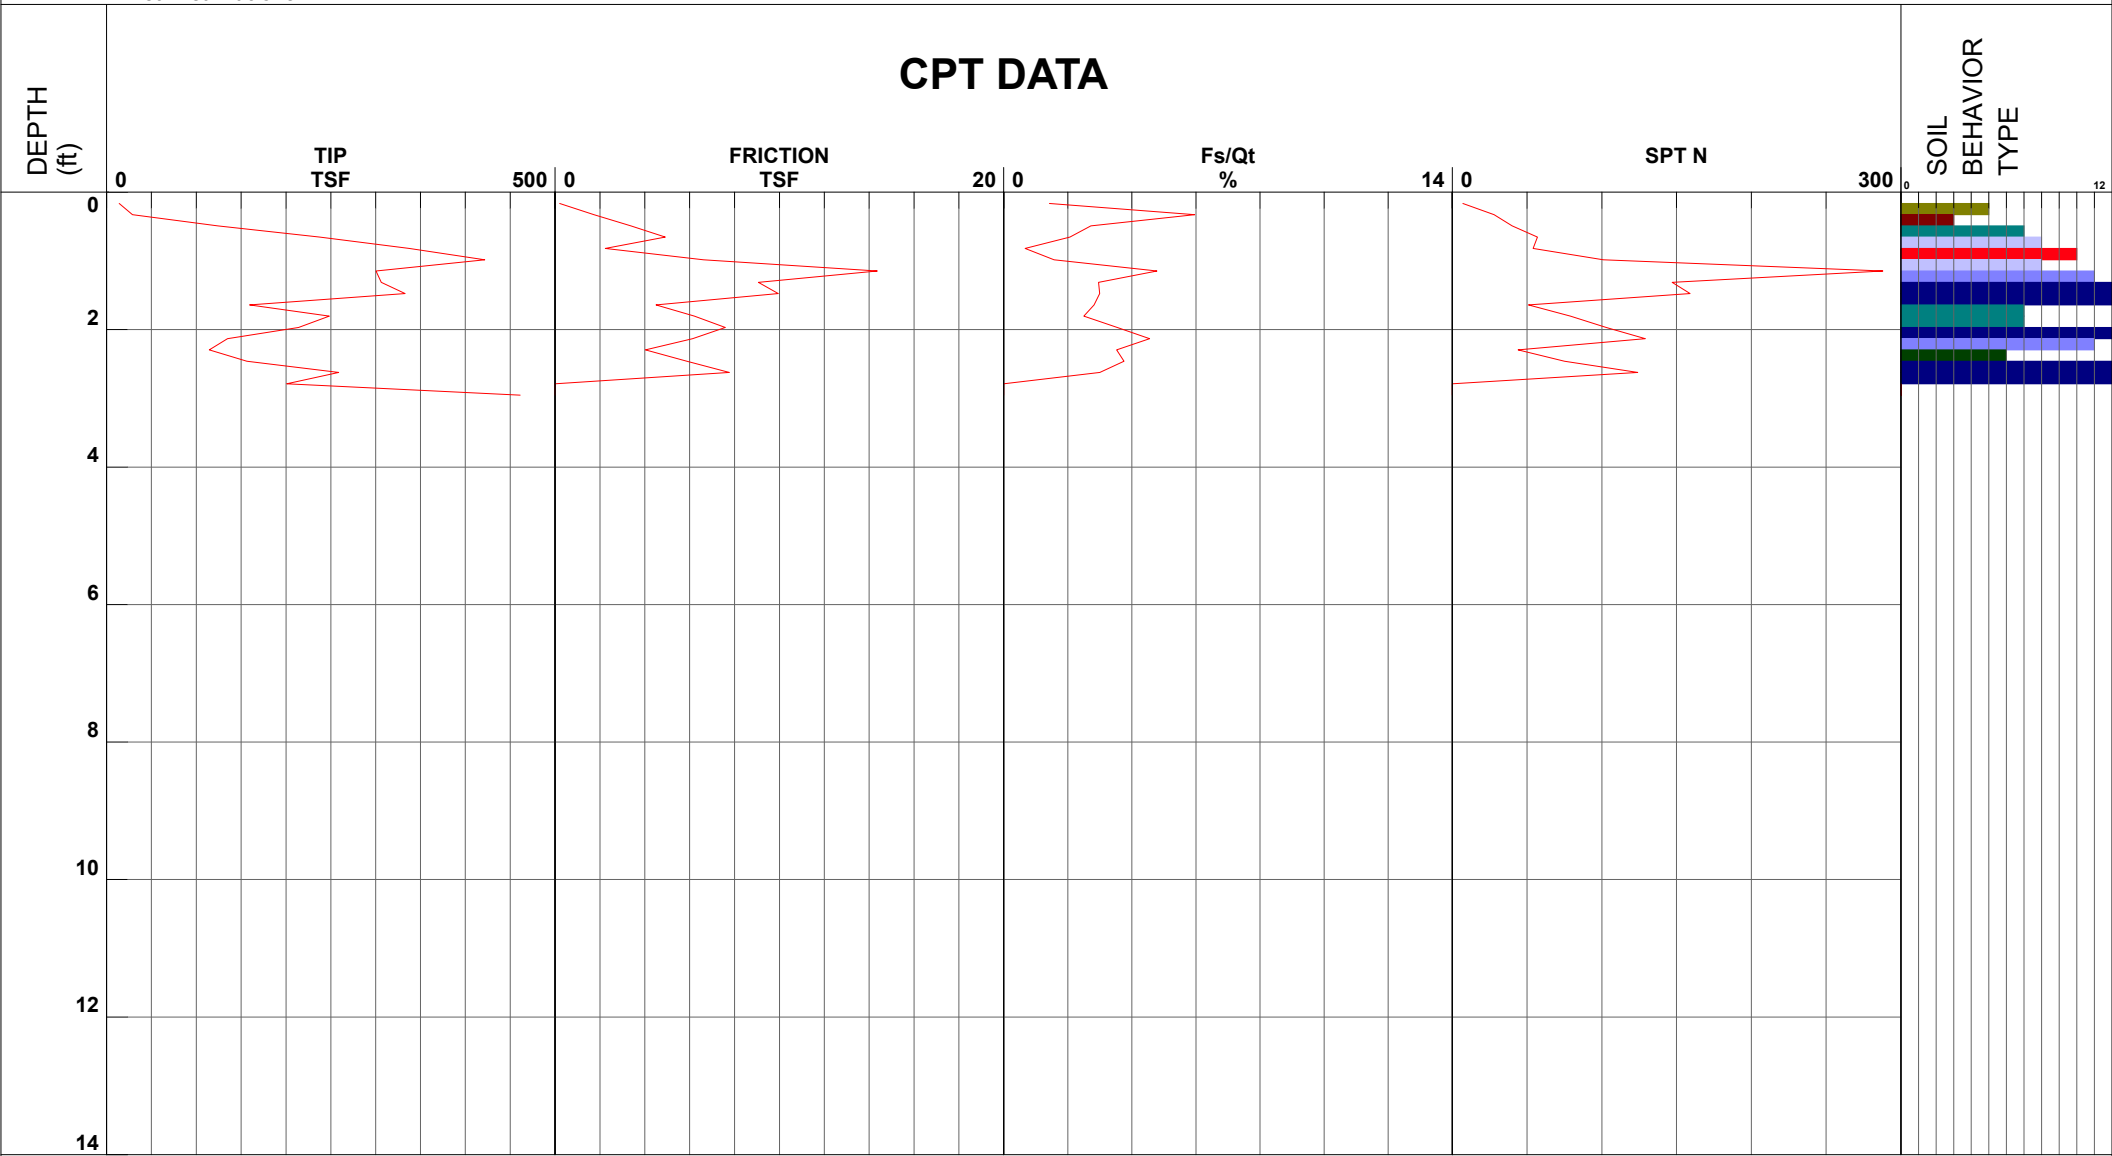
## CPT DATA

- 1 - sensitive fine grained
- 4 - silty clay to clay
- 7 - silty sand to sandy silt
- 10 - gravelly sand to sand
- 2 - organic material
- 5 - clayey silt to silty clay
- 8 - sand to silty sand
- 11 - very stiff fine grained (\*)
- 3 - clay
- 6 - sandy silt to clayey silt
- 9 - sand
- 12 - sand to clayey sand (\*)

Cone Size 10cm squared

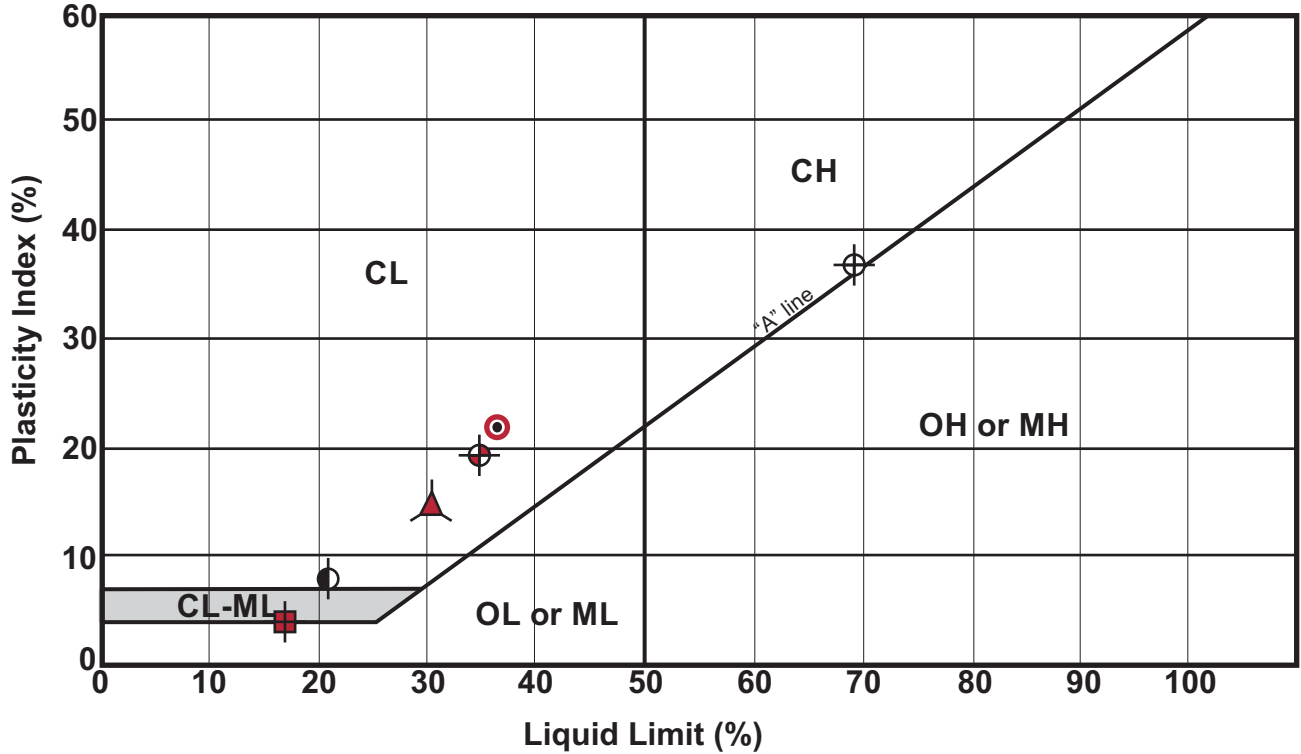
### Plasticity Index (ASTM D4318) Testing Summary

Symbol	Boring No.	Depth (ft)	Natural Water Content (%)	Liquid Limit (%)	Plastic Limit (%)	Plasticity Index	Passing No. 200 (%)	Group Name (USCS - ASTM D2487)
⊗	EB-1	2.0	11	35	16	19	63	Sandy Lean Clay (CL) [Qal]
⊠	EB-2	1.5	8	17	13	4	54	Sandy Silty Clay (CL-ML) [Qal]
⊙	EB-2	3.0	15	36	14	22	55	Sandy Lean Clay (CL) [Qal]
⊠	EB-2	10.5	20	31	16	15	49	Clayey Sand (SC) (CL fines) [Qal]
⊗	EB-3	7.0	29	69	32	37	---	Sandy Claystone [Tw]
⊙	EB-4	2.0	8	21	13	8	48	Clayey Sand (SC) (CL fines) [Qal]

**Plasticity Index:** Six Plasticity Index determinations (ASTM D4318) were performed on samples of the subsurface soils to measure the range of water contents over which the material exhibits plasticity. The Plasticity Index was used to classify the soil in accordance with the Unified Soil Classification System and to evaluate the soil expansion potential. Results of these tests are shown on the boring logs at the appropriate sample depths.
